PLANNING COMMISSION NOTICE AND AGENDA

To: The Planning Commission
From: Niall Connolly
Date: February 13, 2026
Re: Design Development Review for the River Park Expansion Project

Springdale River Park Expansion

Springdale River Park Expansion
Springdale, Utah

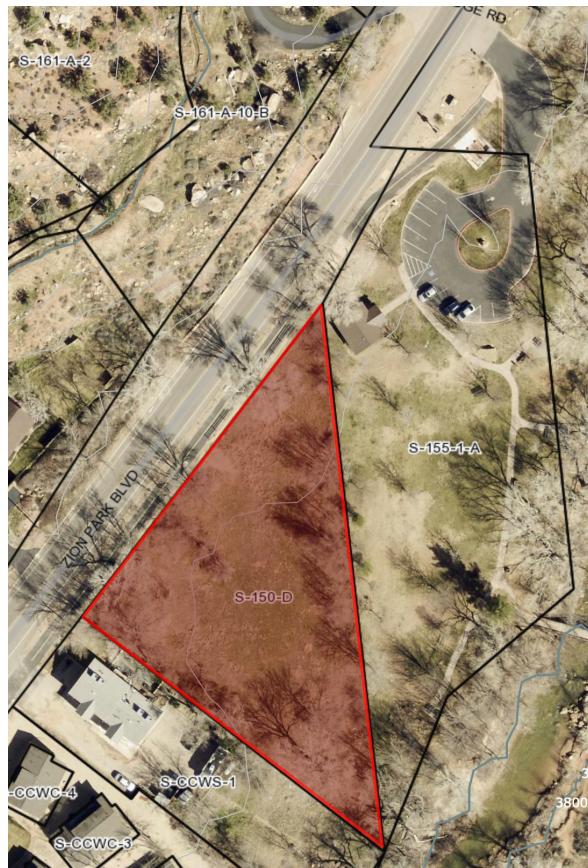
Figure 1. Parcel S-150-D highlighted in red

The Town has acquired a parcel of land directly adjacent to the George A Barker River Park (parcel S-150-D). The Town proposes to extend the park to include this parcel. The existing park is 57,321 sq ft, and this new parcel is 39,824 sq ft, which combined gives a total of 97,145 sq ft, or 2.23 acres.

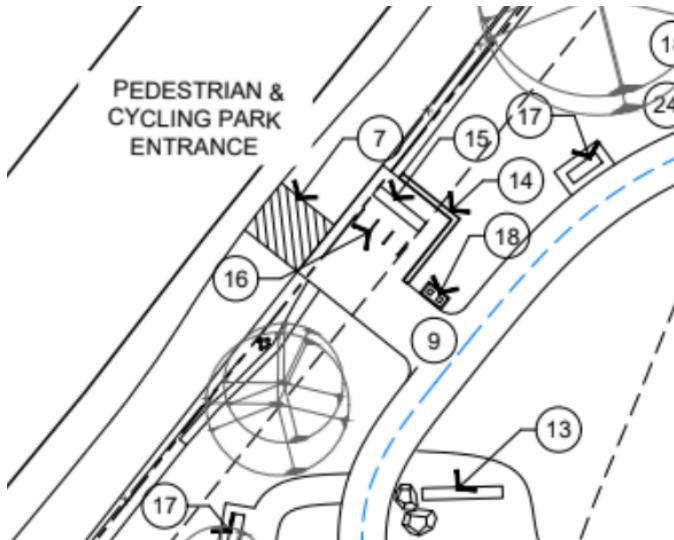
Figure 3. Proposed new pedestrian and cycle entrance

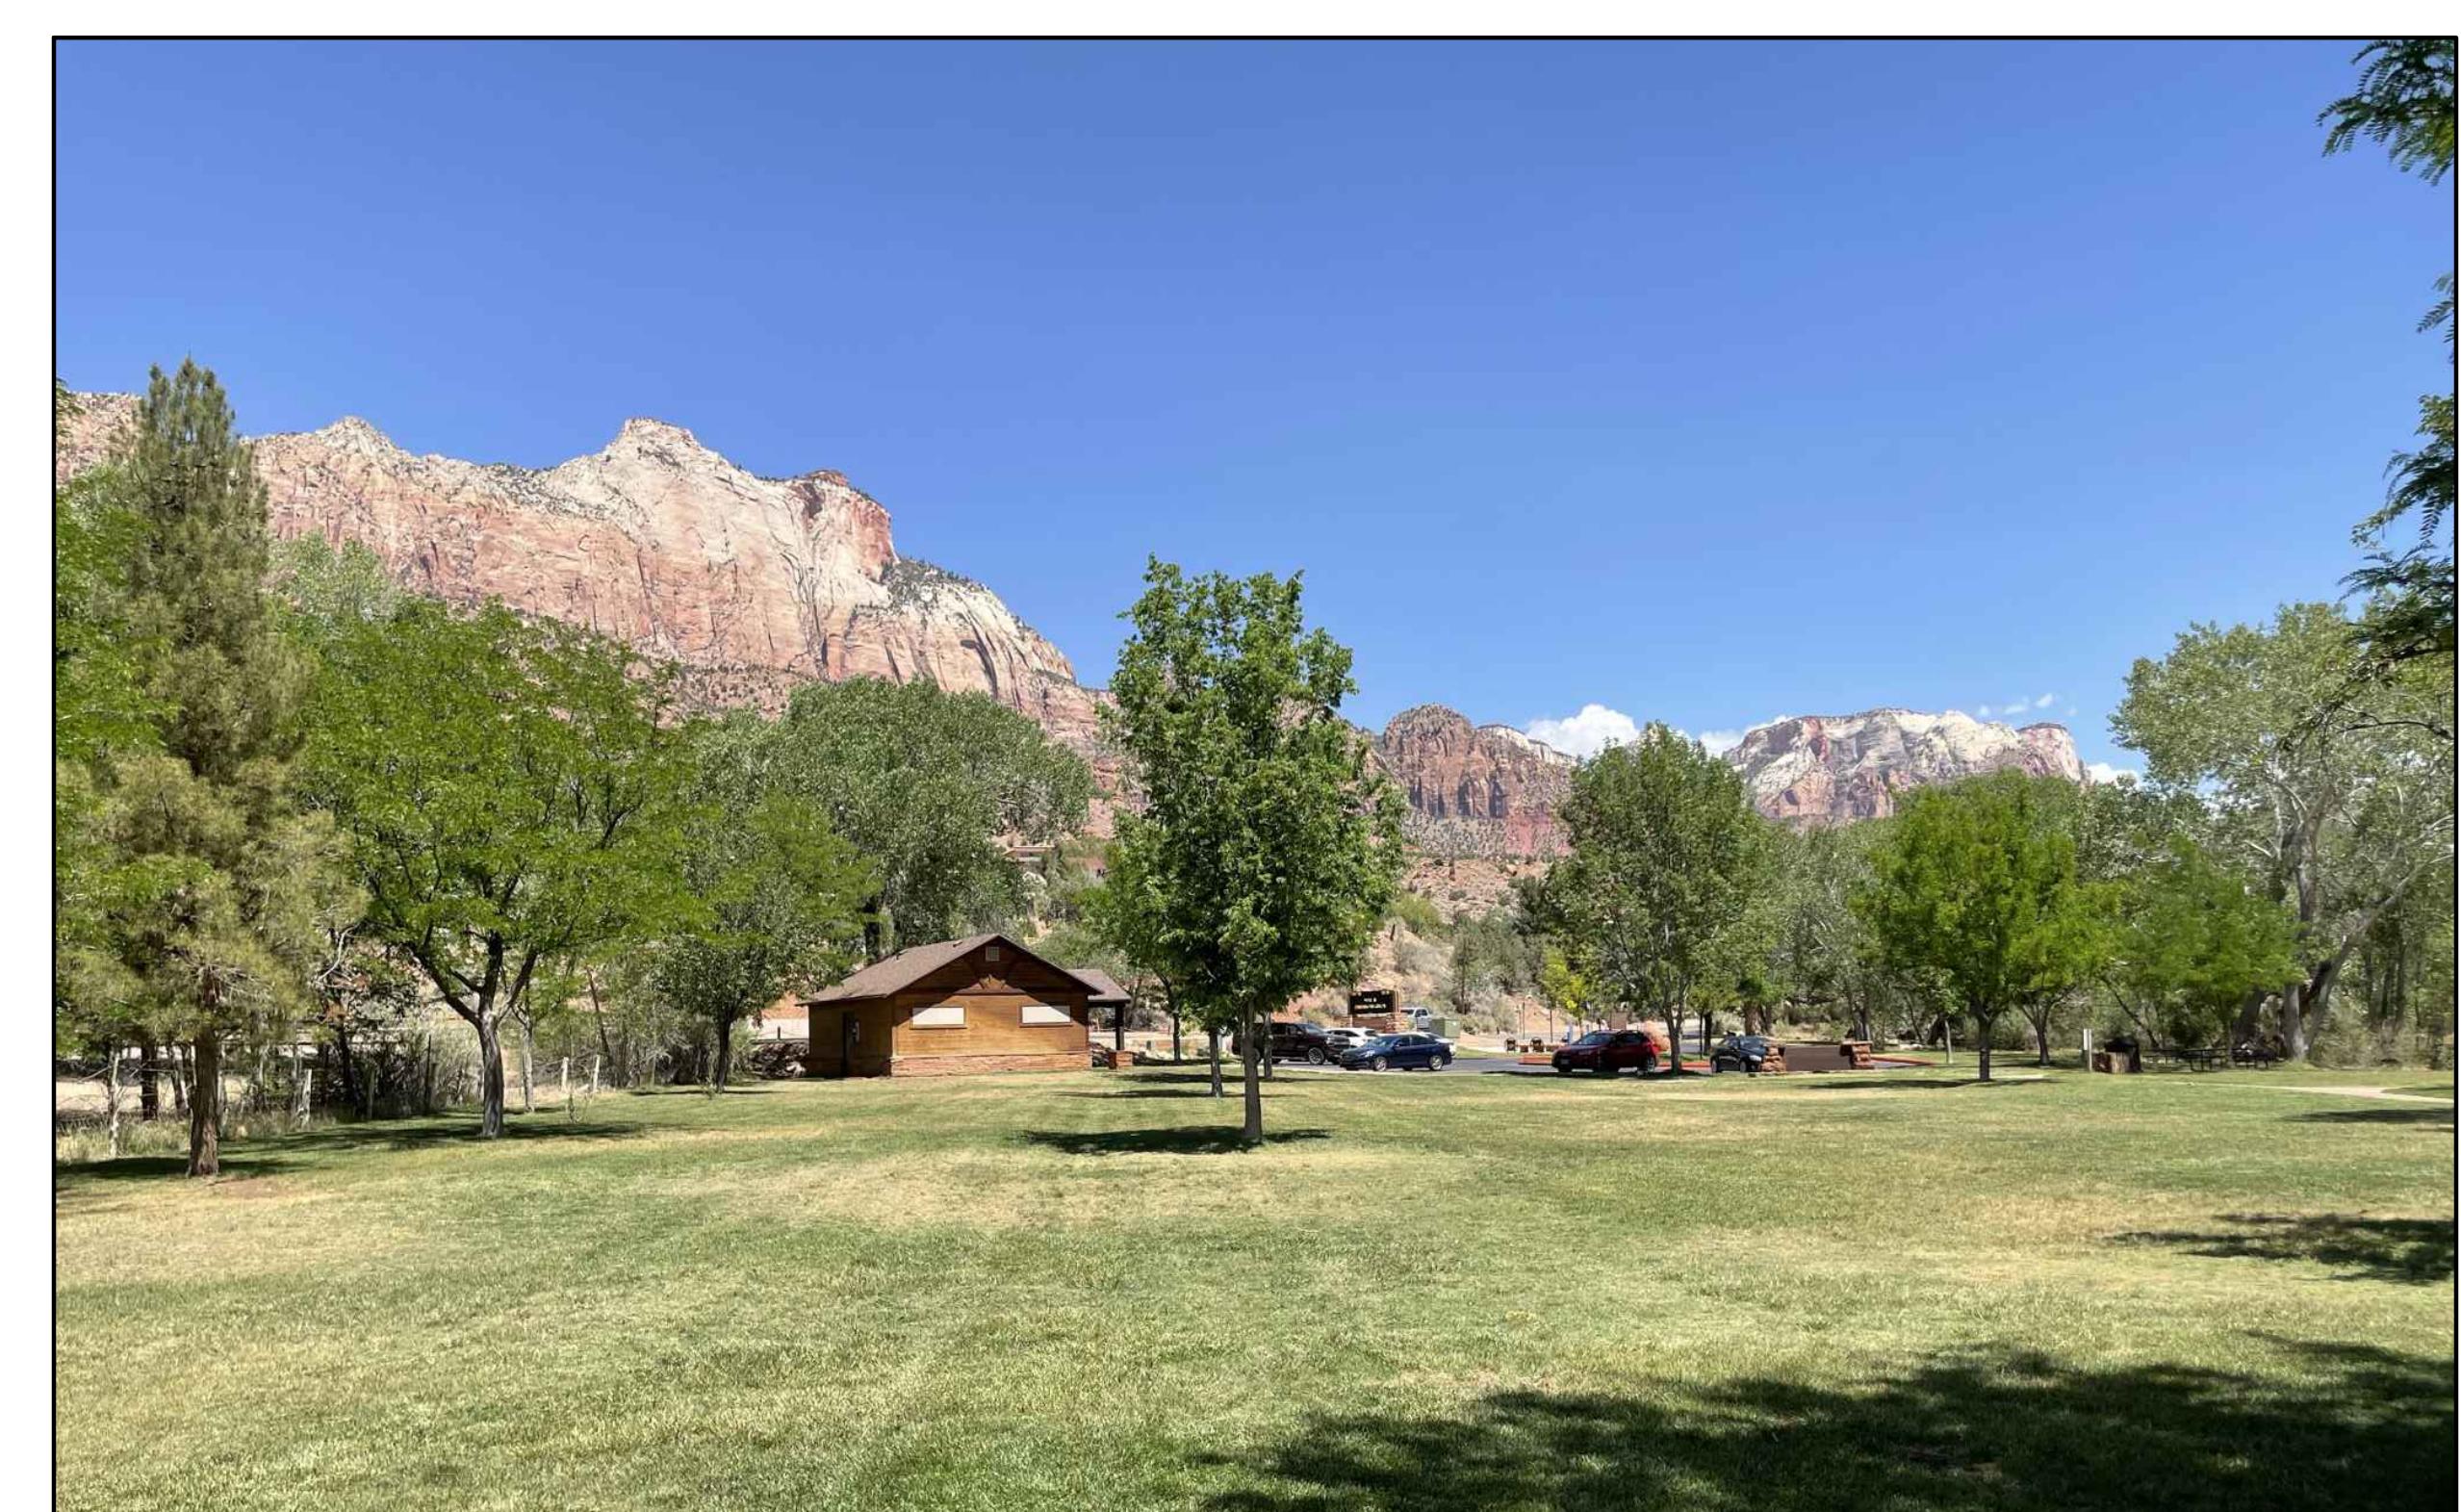
G1.01 NTS

F8 Photo of Existing Restroom

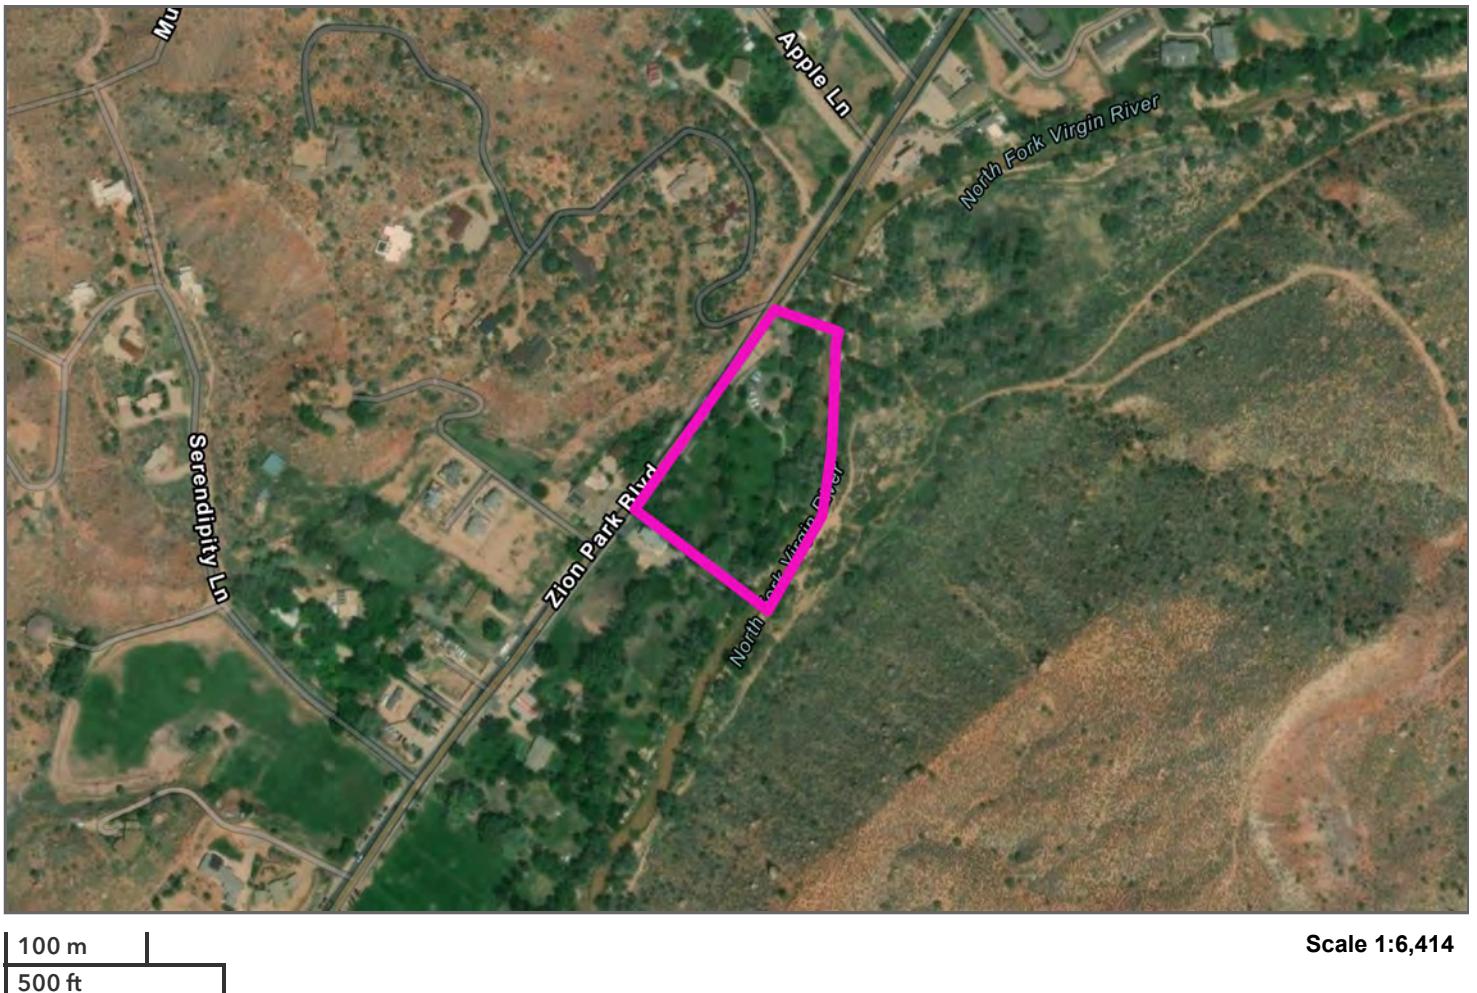
This report contains geologic hazard information and data from the Utah Geological Survey (UGS) and other sources for the area of interest shown on the map below and can be used to identify mapped geologic hazards in an area, understand what the hazards are, and learn potential ways to mitigate them. This report is not a substitute for site-specific geologic hazards and geotechnical engineering investigations by a qualified, Utah-licensed consultant. These investigations provide valuable information on the site geologic conditions that may affect or be affected by development, as well as the type and susceptibility of geologic hazards at a site and recommend solutions to mitigate the effects and costs of the hazards, both at the time of construction and over the life of the development. See your local city or county building department for details on these investigations and UGS Circular 122 (<https://ugspub.nr.utah.gov/publications/circular/c-122.pdf>). Since 1850, at least 5797 deaths and an undetermined financial cost have been attributed to geologic hazards in Utah. Damages resulting from many geologic hazards are often not covered by property or other insurance. In almost all cases, it is more cost effective to investigate and characterize potential hazards and implement appropriate mitigation, rather than rely on additional maintenance over the life of a project and/or incur costly construction change orders and other financial costs.

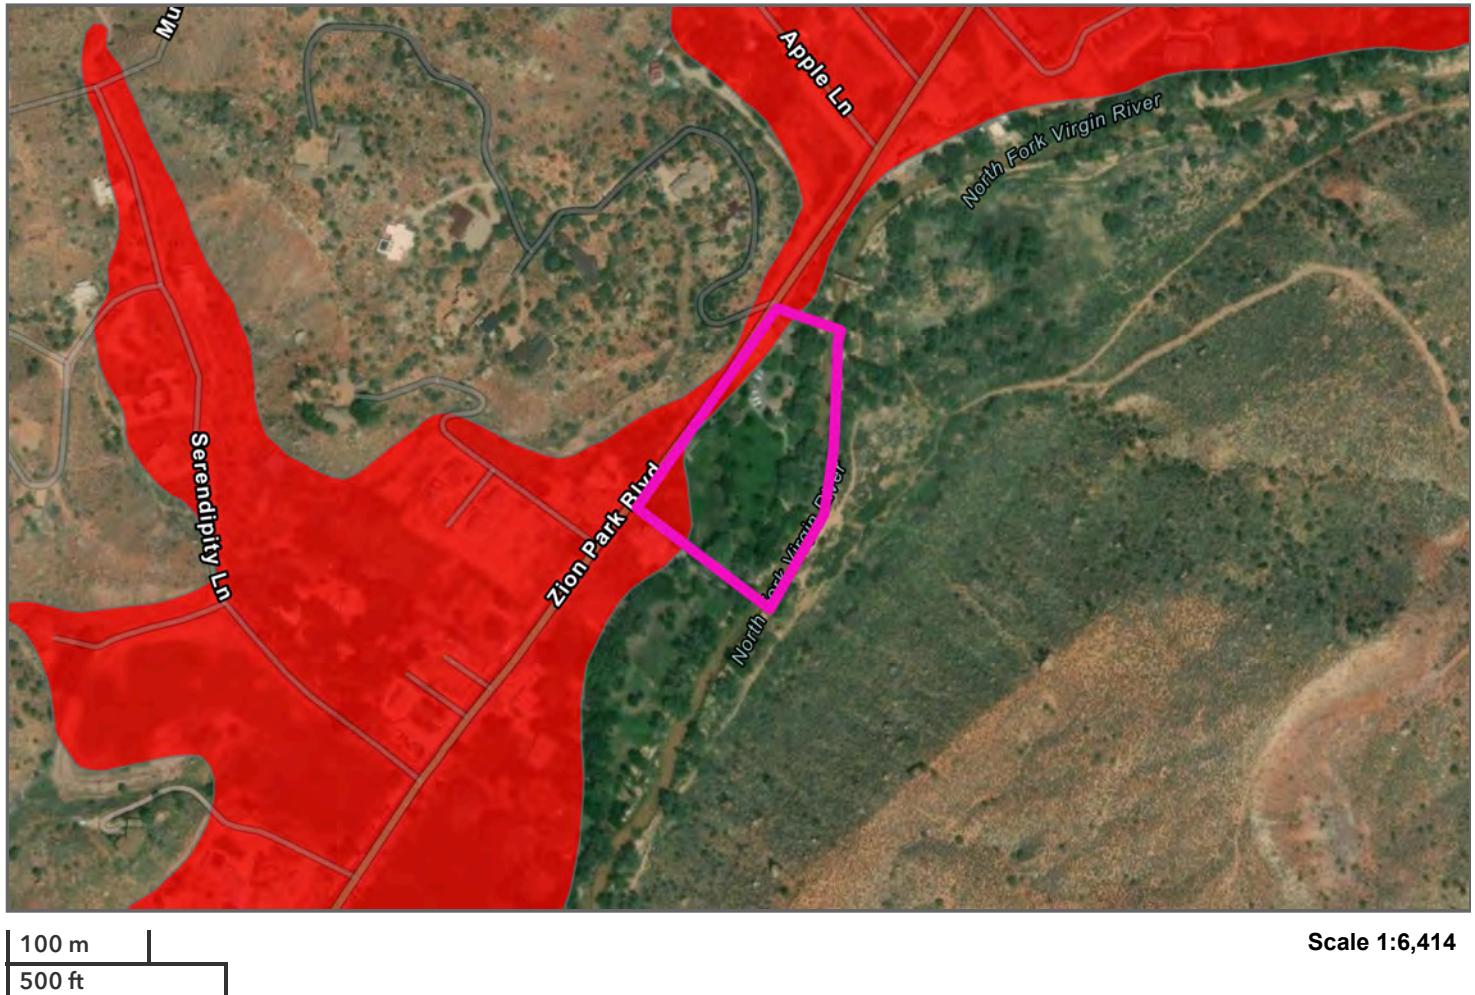
- Very high liquefaction susceptibility, includes highly susceptible geologic units consisting of well-sorted sand, silty sand, and gravel along modern stream drainages, young alluvial terraces, and lacustrine deposits where the depth to groundwater is less than or equal to 10 feet.

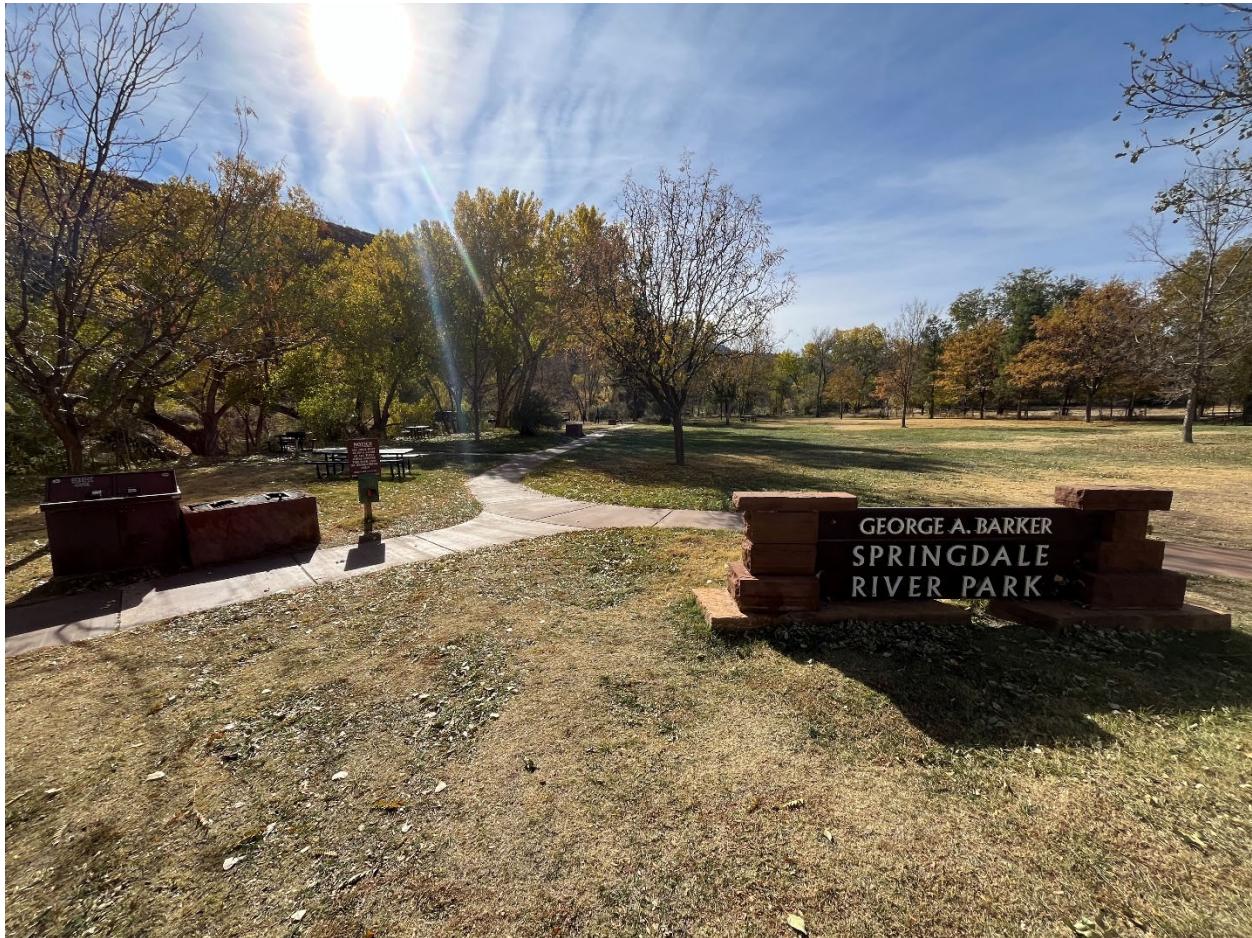
Figure 2 – November 11, 2024. Image of George Barker Springdale River Park, looking south from the edge of the parking lot. The North Fork of the Virgin River is located behind the mature cottonwoods on the left side of the image. These cottonwoods provide some erosion protection for the park. The proposed improvements are partially located within the HREHZ and MREHZ.

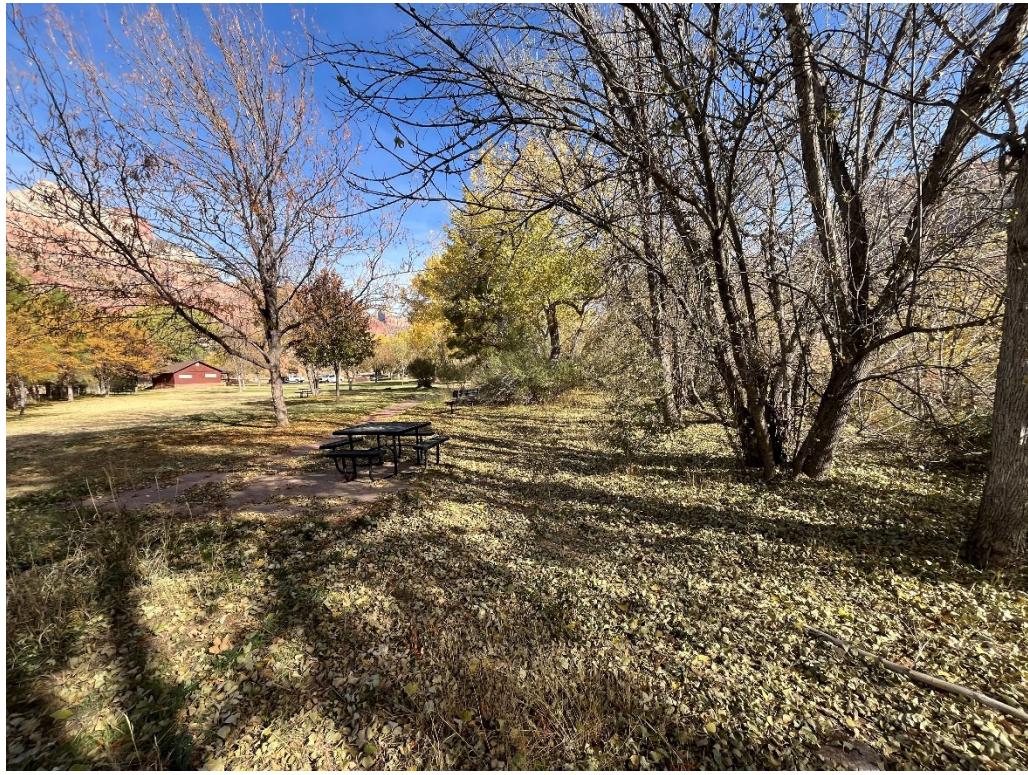
Figure 3 – November 11, 2024. Looking upstream from the downstream edge of the park along the right (west) low terrace. The proposed improved restroom facility and covered pavilion are to be located near the current restroom (red building on the left side of the image).

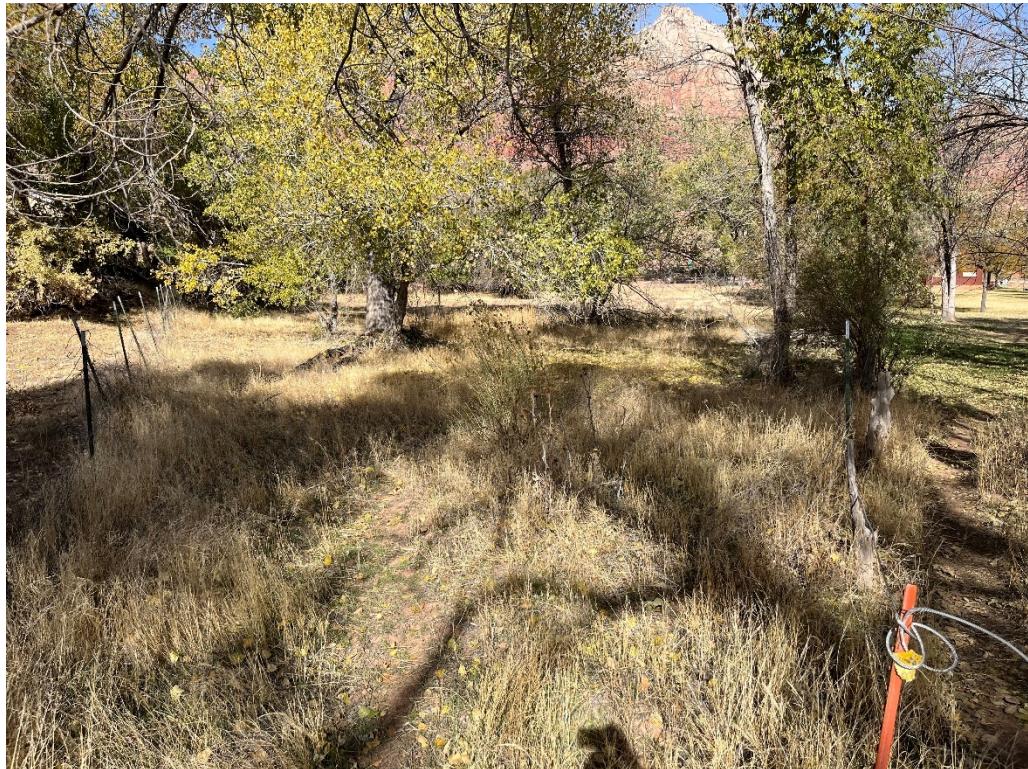
Figure 4 – November 11, 2024. Image of the undeveloped area south of the existing river park, where the expansion is proposed to take place. The low terrace is vegetated with a few mature cottonwoods and herbaceous vegetation in the understory.

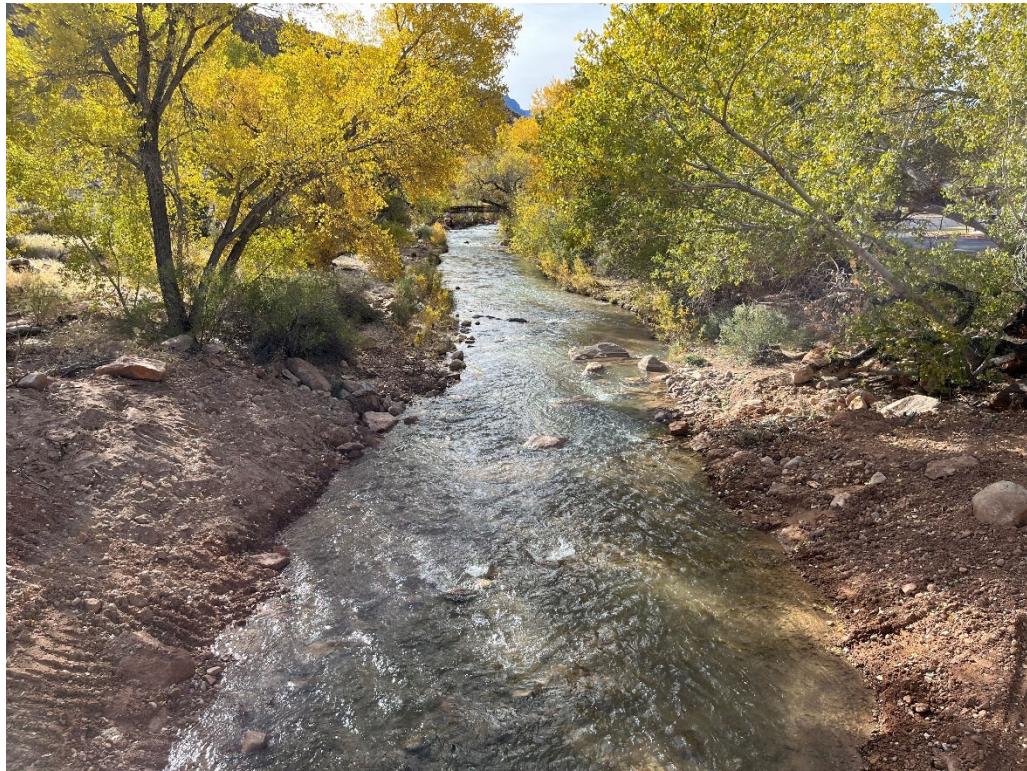
Figure 5 – November 11, 2024. Looking downstream from the pedestrian bridge north of the river park. Recent disturbance from the erosion protection installed along the right (west) overbank is visible in the front of the image. The moderately vegetated, steep and narrow floodplains are visible on either side of the river through this portion of the study reach.

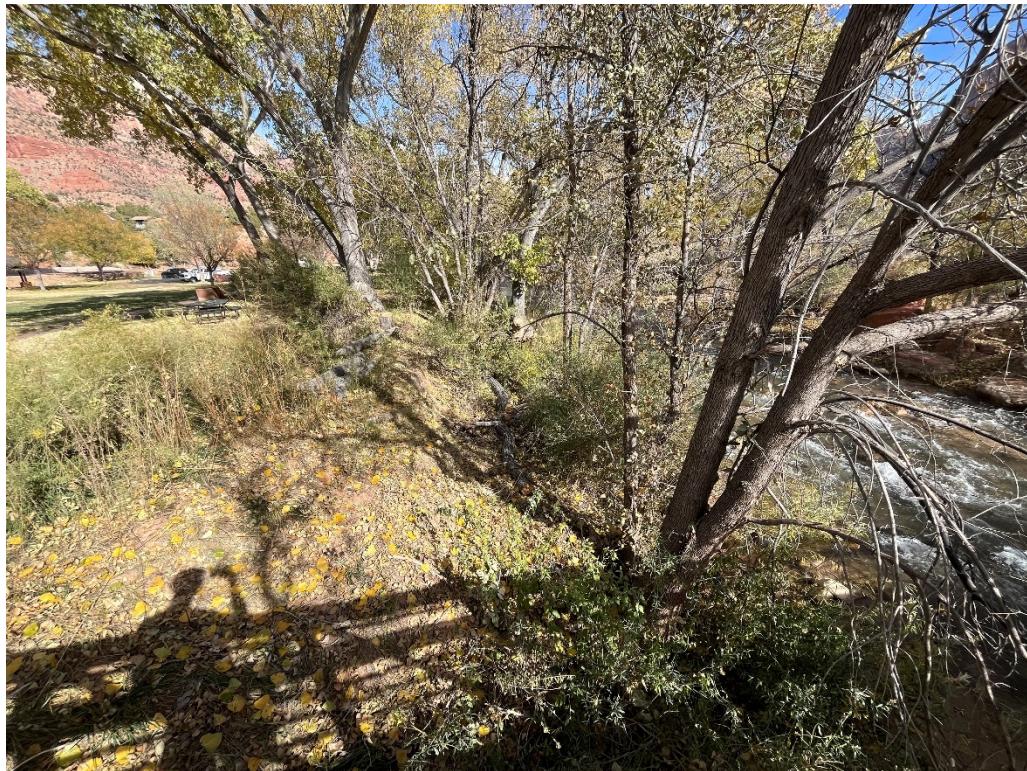
Figure 6 – November 11, 2024. Looking upstream along the right (west) overbank of the North Fork of the Virgin River adjacent to the existing river park. Work associated with the proposed park expansion will not disturb the overbank area, allowing the existing vegetation to continue to provide some erosion protection.

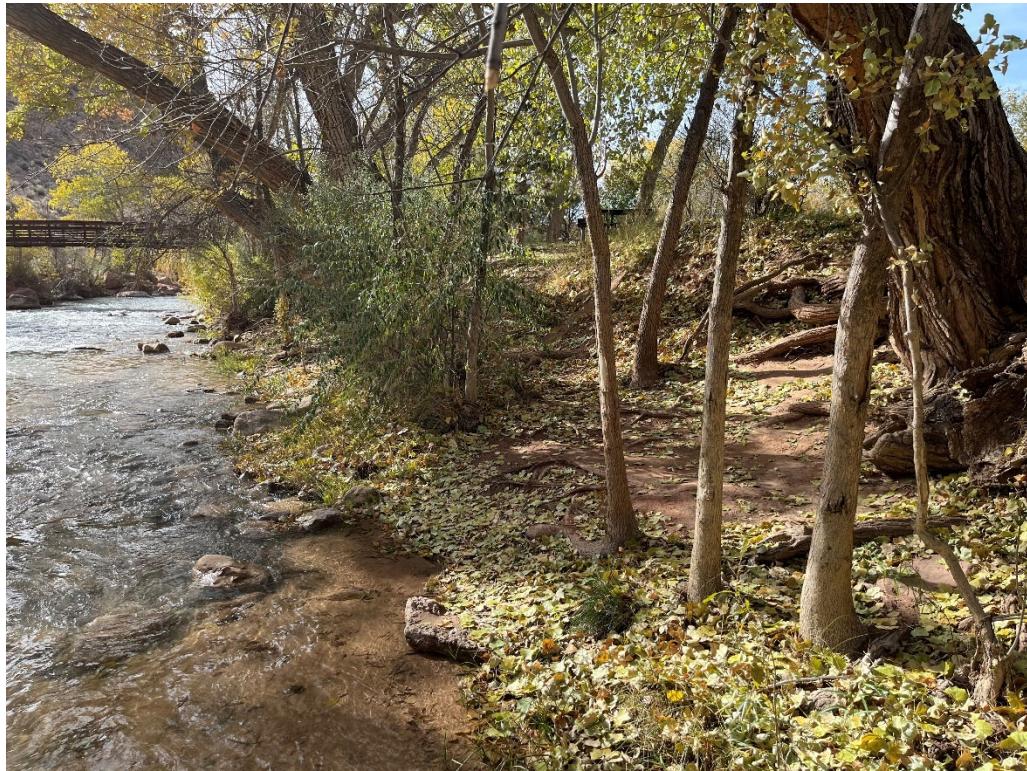
Figure 7 – November 11, 2024. Looking downstream along the right (west) overbank of the North Fork of the Virgin River. The lack of vegetation in the understory within some section of the active floodplain can likely be attributed to erosion occurring during high flow events and foot traffic from park visitors.

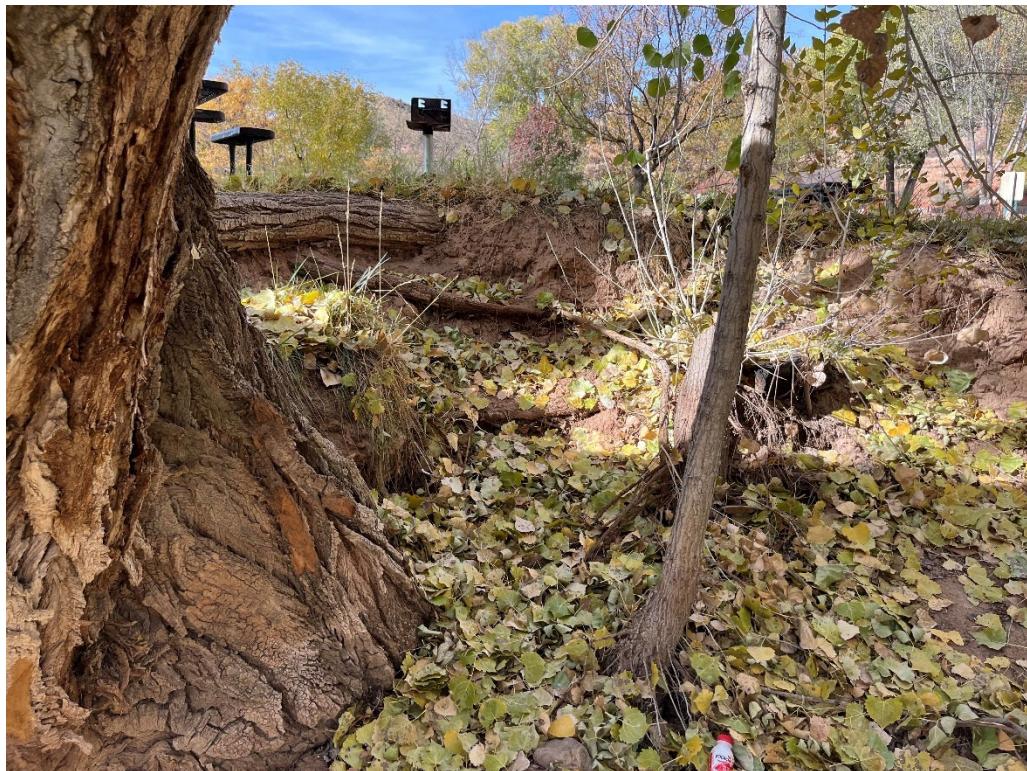
Figure 8 – November 11, 2024. Small (1-2') vertical cutbank located along the right (west) overbank of the North Fork of the Virgin River, approximately 50 feet upstream of the southern pedestrian bridge.

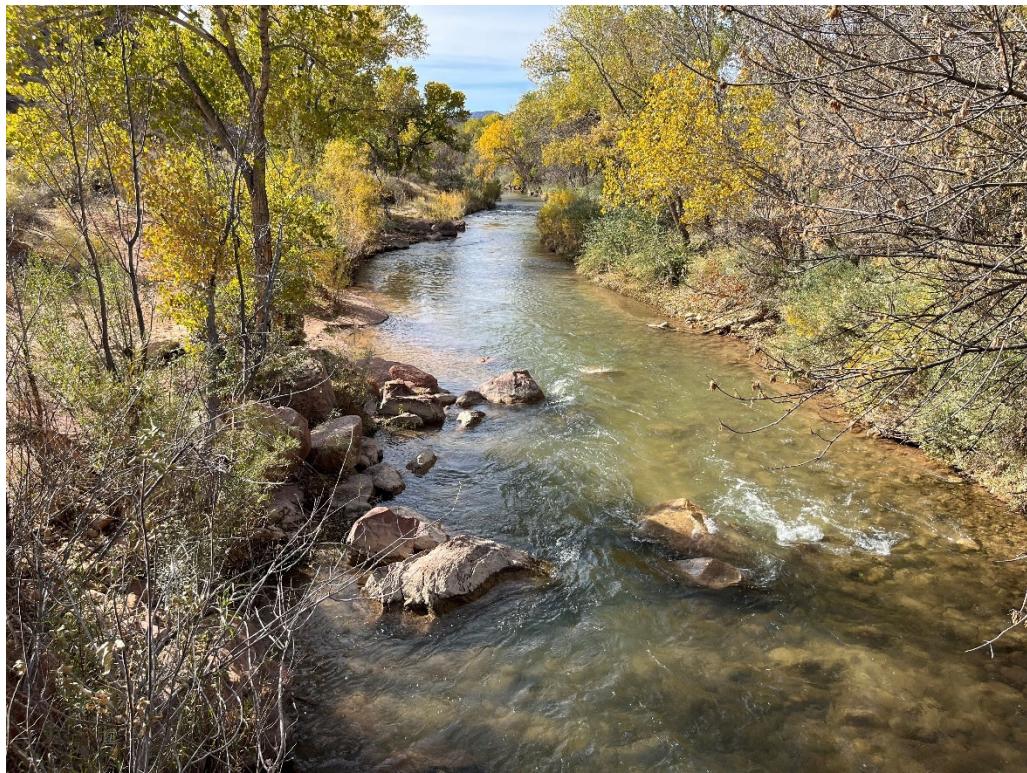
Figure 8 – November 11, 2024. Looking downstream from the southern pedestrian bridge. The active floodplain along both overbanks is well vegetated with cottonwoods in varying life stages, coyote willows, mule fat, and herbaceous vegetation.

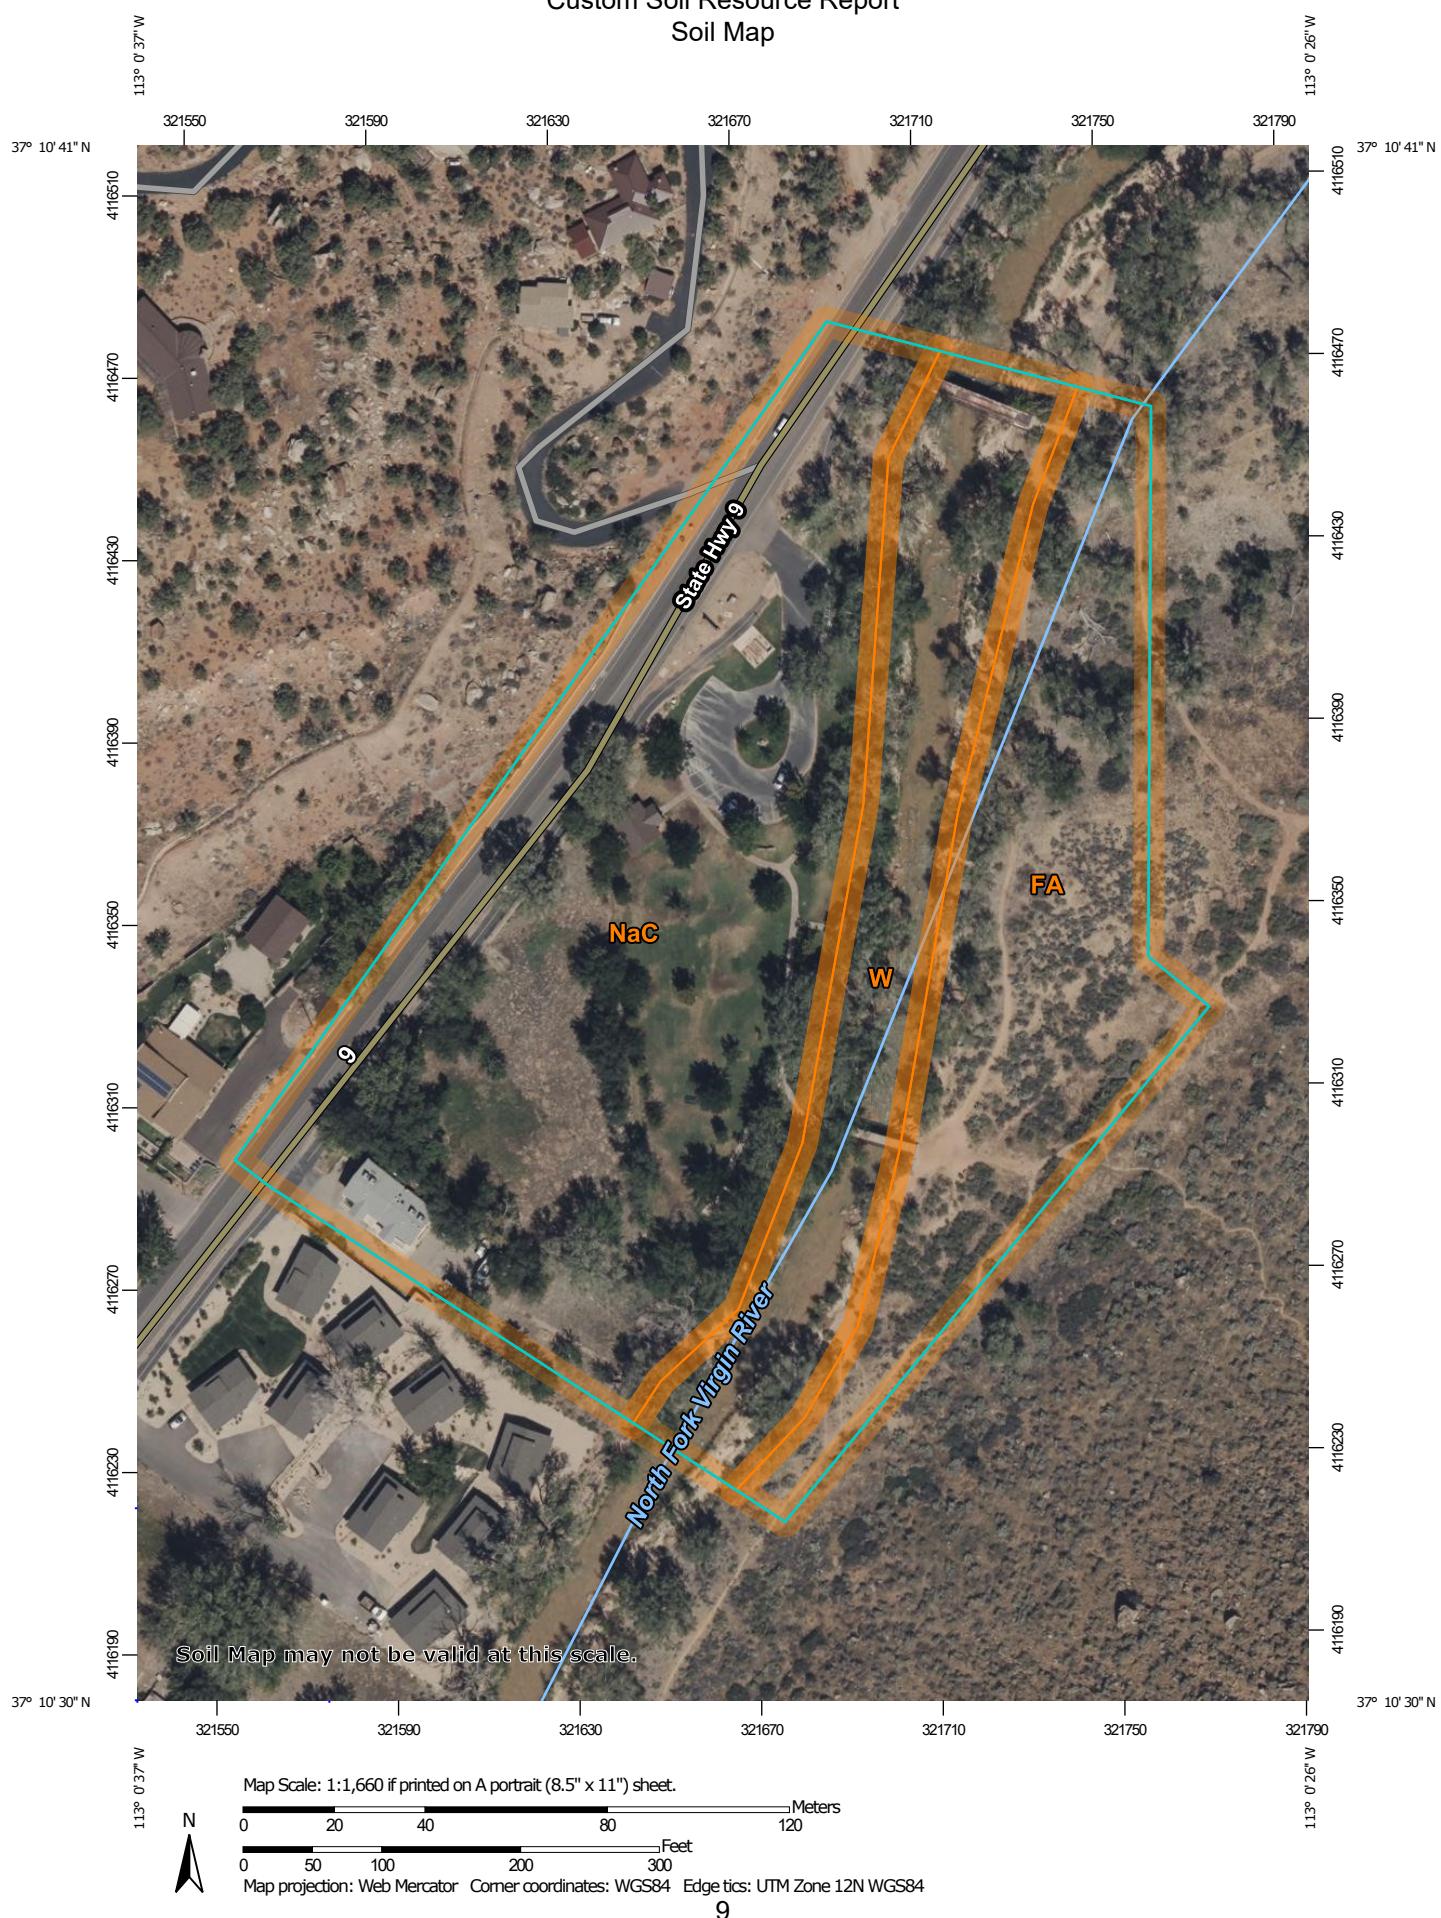
Custom Soil Resource Report
Soil Map

The soil map section includes the soil map for the defined area of interest, a list of soil map units on the map and extent of each map unit, and cartographic symbols displayed on the map. Also presented are various metadata about data used to produce the map, and a description of each soil map unit.
