To: The Planning Commission
From: Niall Connolly
Date: February 13, 2026
Re: Erosion Hazard Permit for the River Park Expansion Project

EROSION HAZARD ASSESSMENT

Springdale River Park Expansion
Springdale, Utah

Rosenberg Associates
Project No: 6650-24-005
January 16, 2026

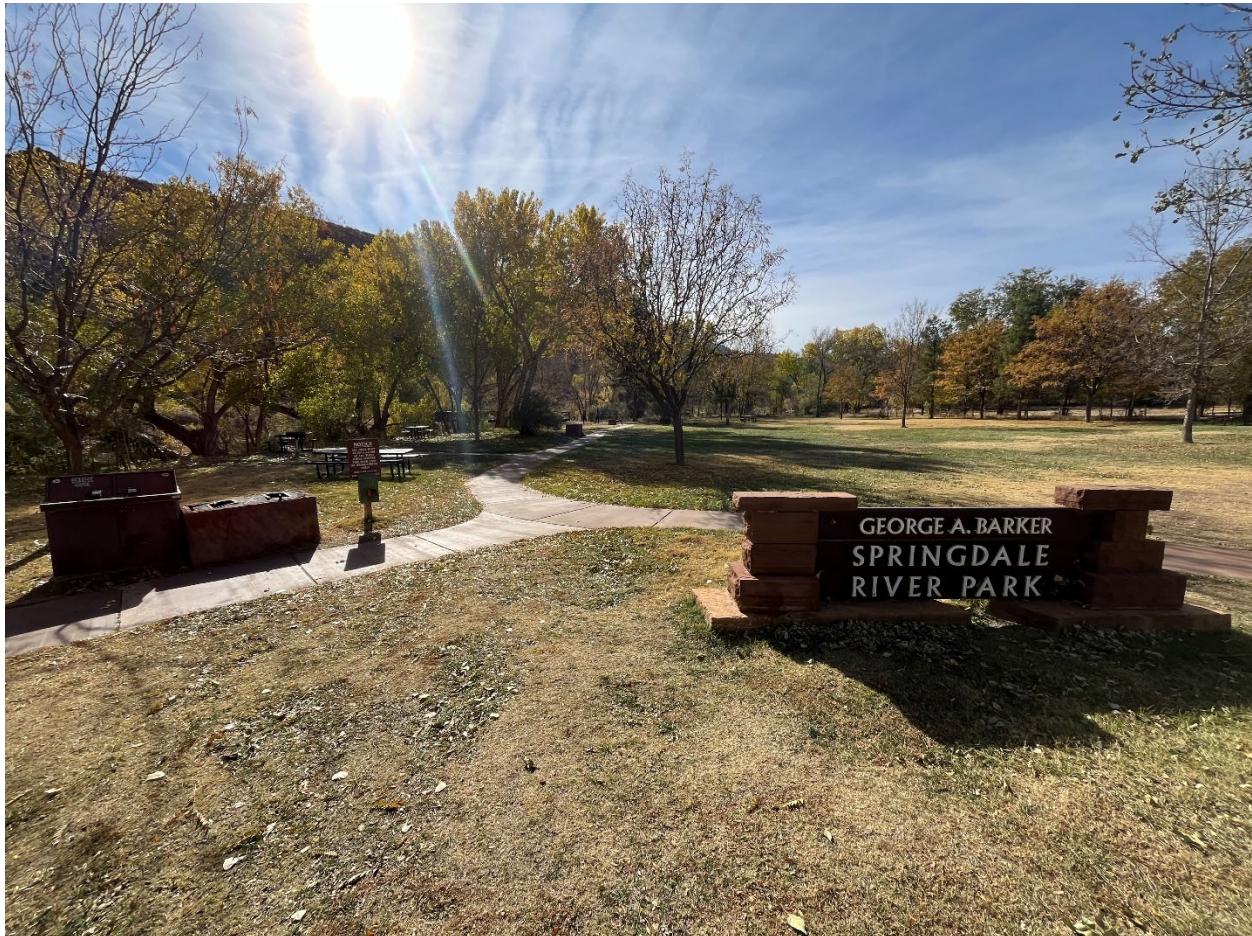
Figure 2 – November 11, 2024. Image of George Barker Springdale River Park, looking south from the edge of the parking lot. The North Fork of the Virgin River is located behind the mature cottonwoods on the left side of the image. These cottonwoods provide some erosion protection for the park. The proposed improvements are partially located within the HREHZ and MREHZ.

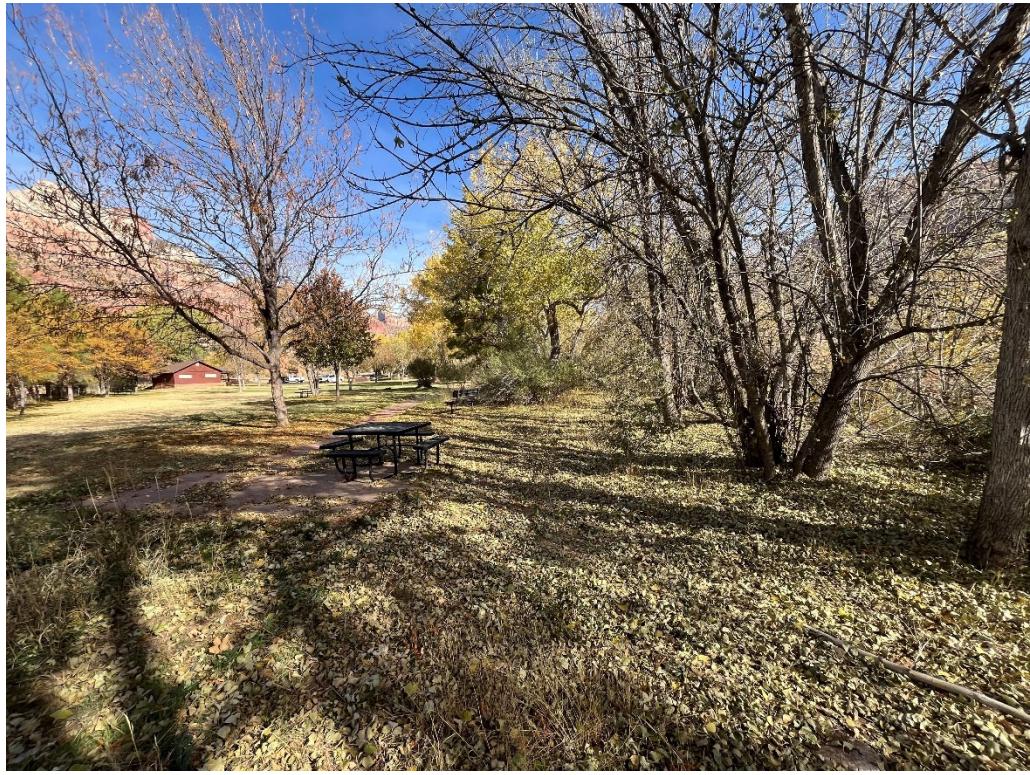
Figure 3 – November 11, 2024. Looking upstream from the downstream edge of the park along the right (west) low terrace. The proposed improved restroom facility and covered pavilion are to be located near the current restroom (red building on the left side of the image).

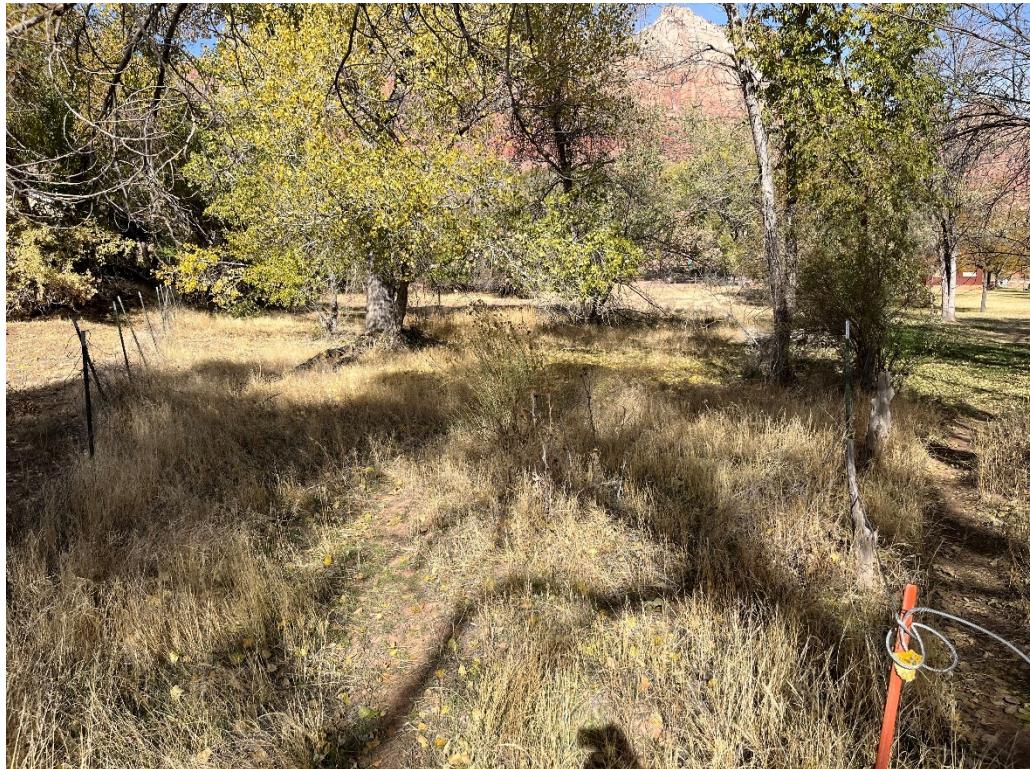
Figure 4 – November 11, 2024. Image of the undeveloped area south of the existing river park, where the expansion is proposed to take place. The low terrace is vegetated with a few mature cottonwoods and herbaceous vegetation in the understory.

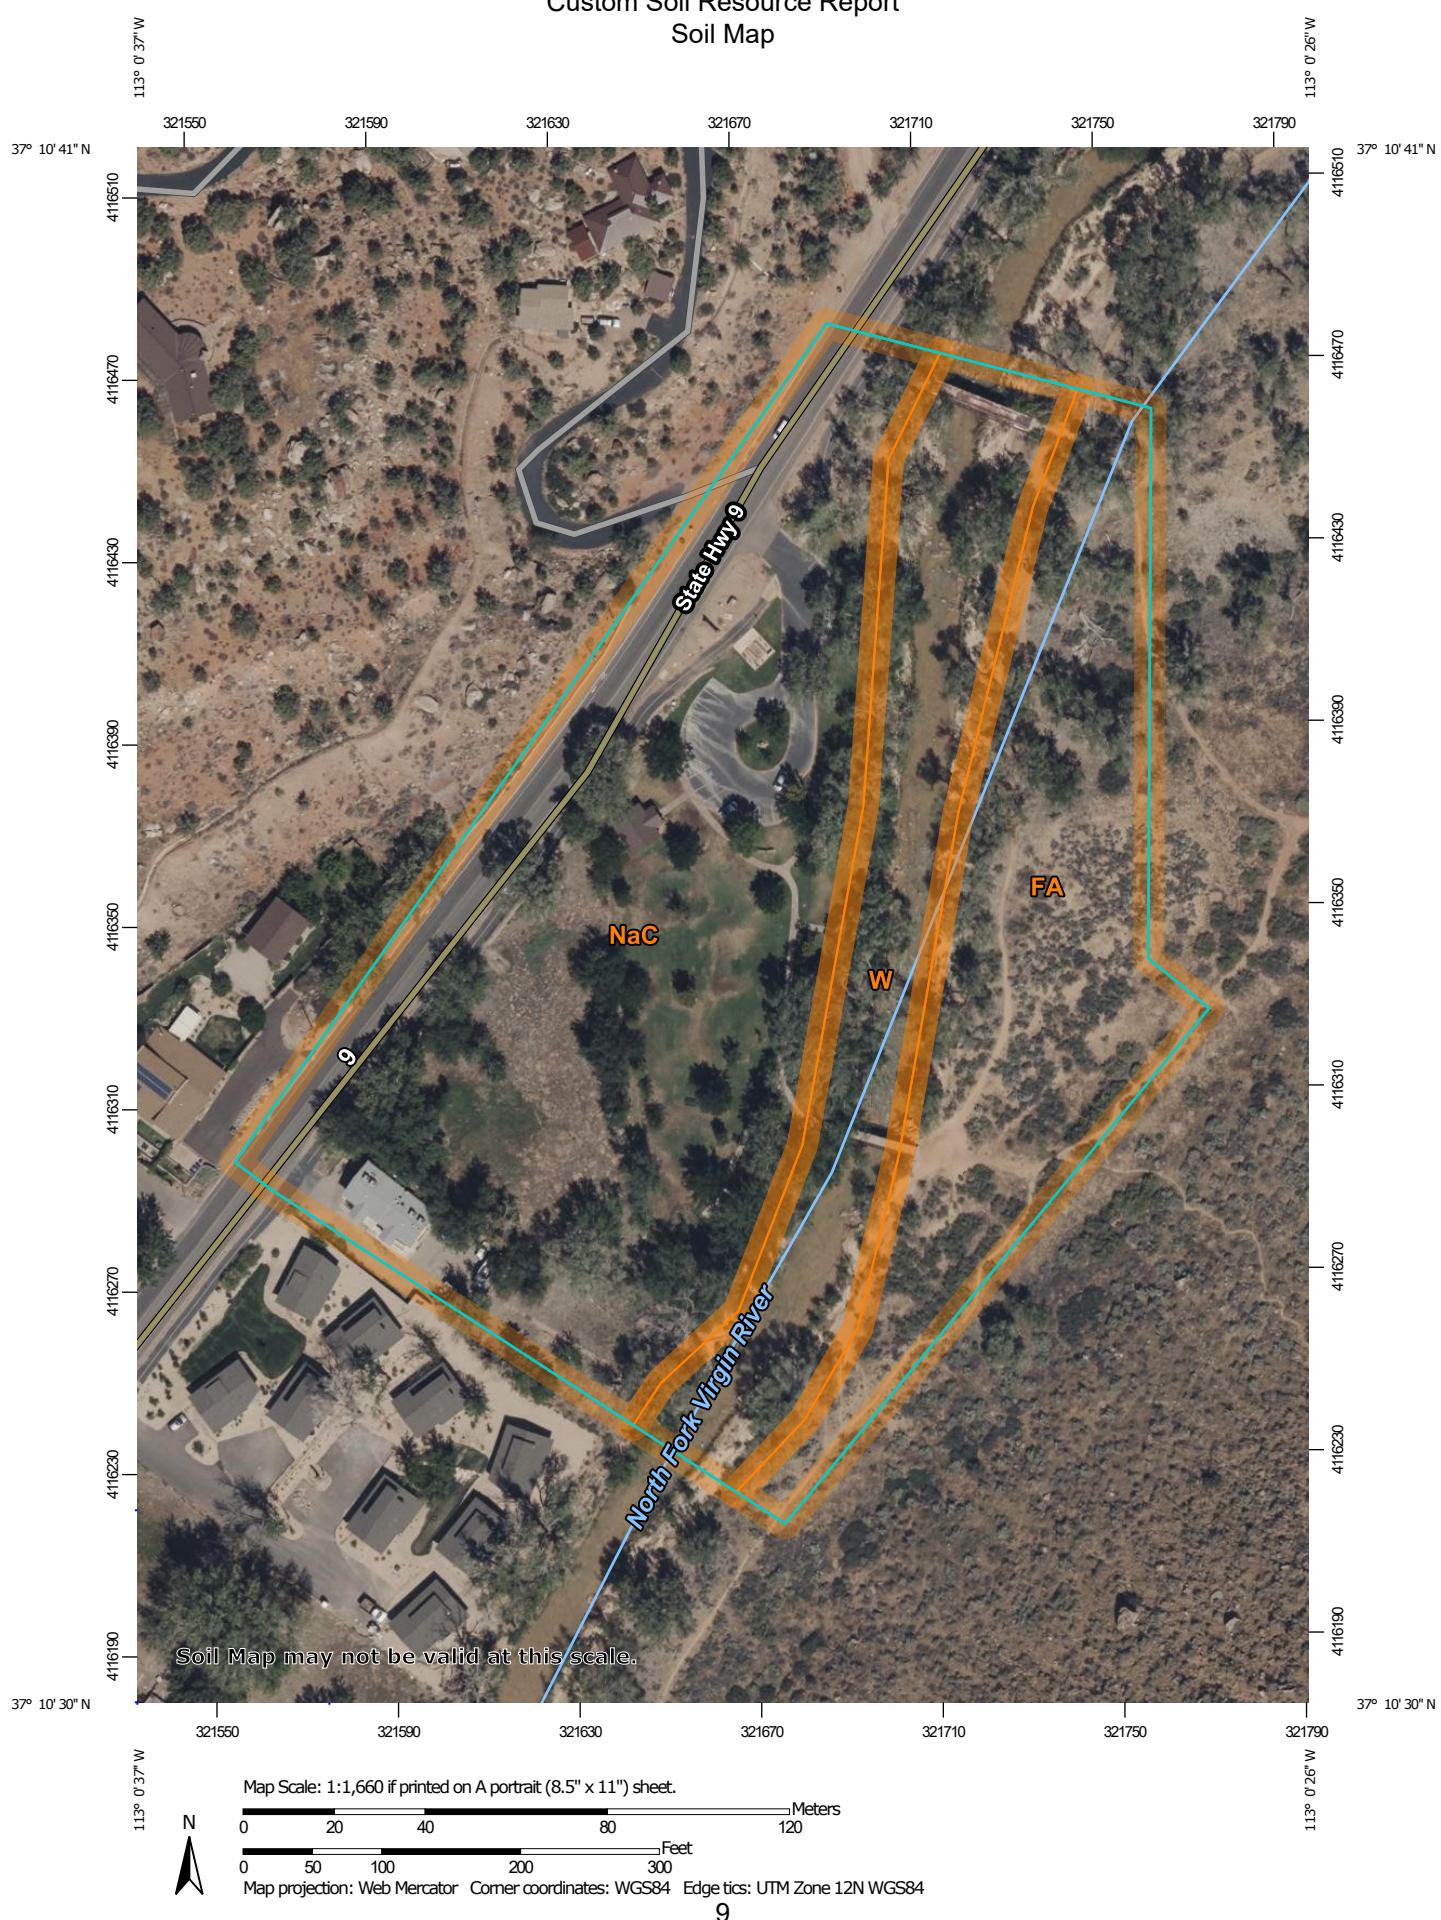
Custom Soil Resource Report
Soil Map

The soil map section includes the soil map for the defined area of interest, a list of soil map units on the map and extent of each map unit, and cartographic symbols displayed on the map. Also presented are various metadata about data used to produce the map, and a description of each soil map unit.

The NRCS has classified soils within most of the project area as NaC – Naplene silt loam, 2 to 6 percent slopes (Reference 2). The NaC soil unit is a relatively loose, silty loam associated with alluvial fans and valleys. These soils generally have a minimum distance to lithic bedrock of 80". These soil units within the project area have a high potential for erosion and scour damage due to their composition and location.
