# SPRINGDALE

***Memorandum***

**To:** The Planning Commission  
**From:** Niall Connolly  
**Date:** February 13, 2026  
**Re:** Design Development Review for the River Park Expansion Project

## Springdale River Park Expansion

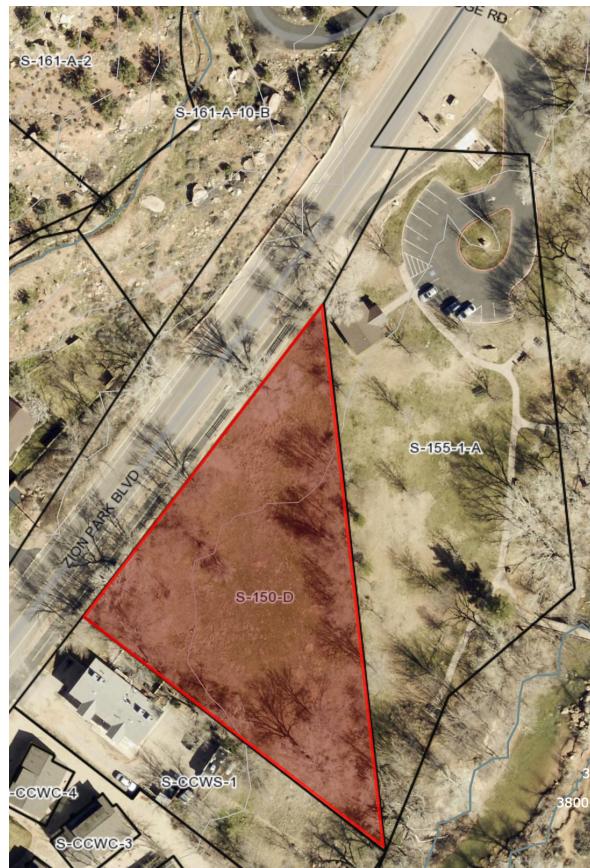
**Figure 1. Parcel S-150-D highlighted in red**

The Town has acquired a parcel of land directly adjacent to the George A Barker River Park (parcel S-150-D). The Town proposes to extend the park to include this parcel. The existing park is 57,321 sq ft, and this new parcel is 39,824 sq ft, which combined gives a total of 97,145 sq ft, or 2.23 acres.

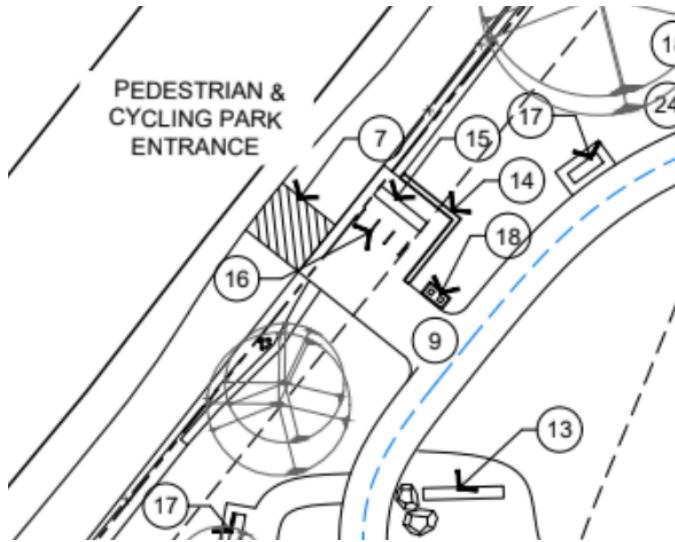
**Figure 3. Proposed new pedestrian and cycle entrance**

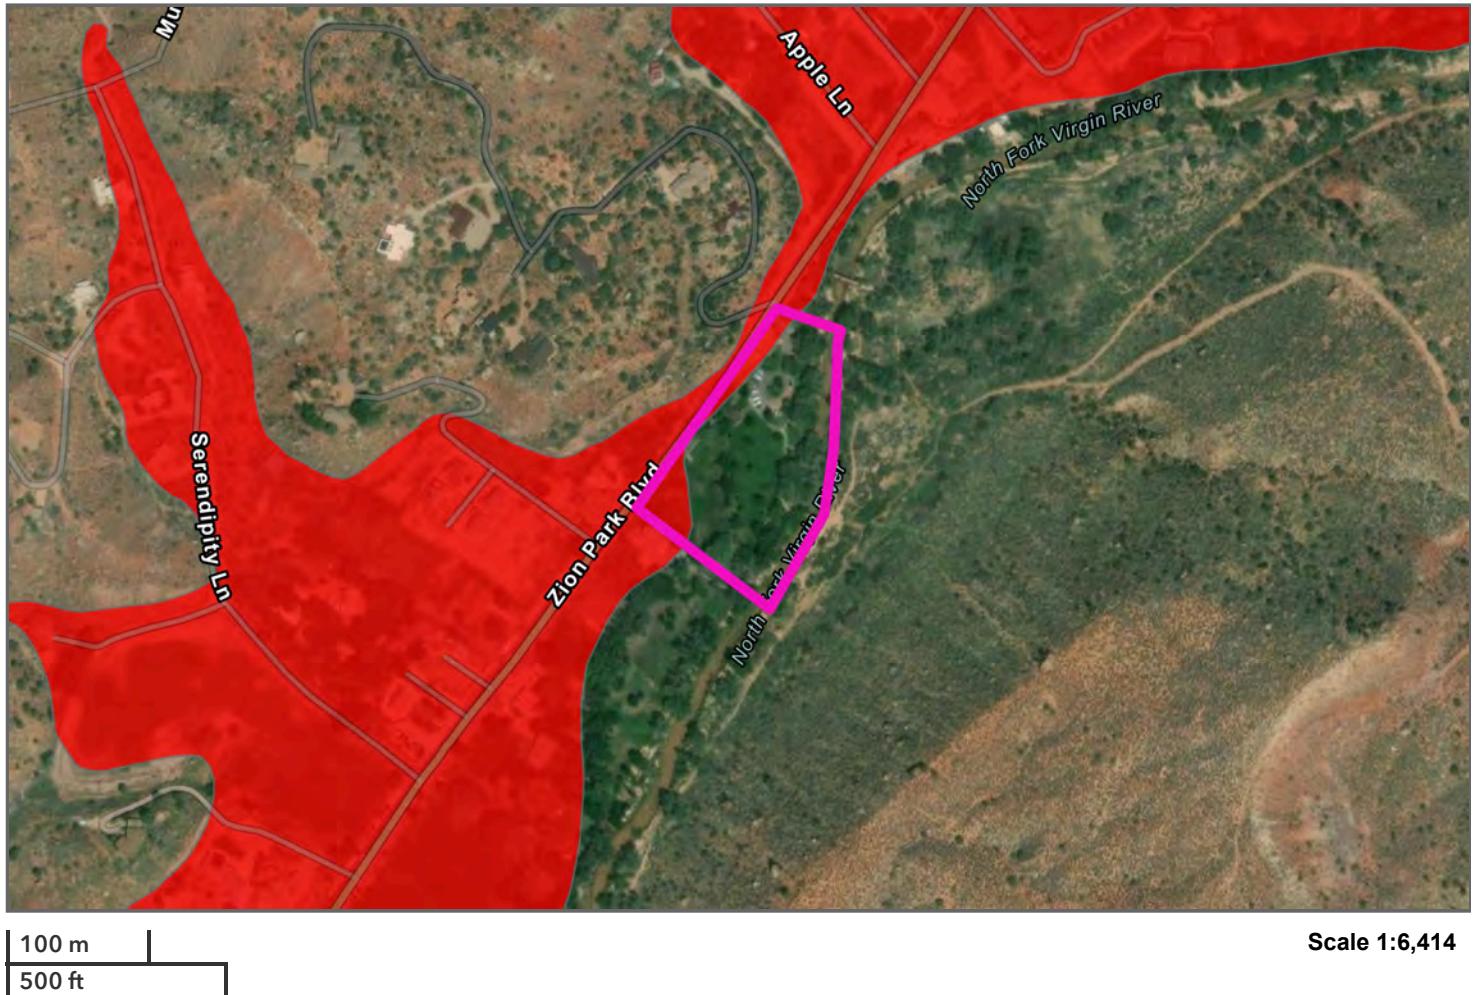
- Very high liquefaction susceptibility, includes highly susceptible geologic units consisting of well-sorted sand, silty sand, and gravel along modern stream drainages, young alluvial terraces, and lacustrine deposits where the depth to groundwater is less than or equal to 10 feet.
